Acetech Home Inspections Inc.

Client(s): **Sample Client**
Property address: **Sample Property Address**
Inspection date: **Tuesday, May 14, 2019**

Sample Property Inspection Report

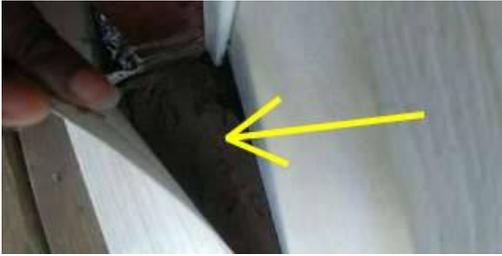
13) *Repair/Replace* - Flashing at one or more locations was missing and/or substandard. Leaks can occur as a result. Recommend that a qualified person repair, replace or install flashing as necessary, and per standard building practices.

Photo 13-1 Missing caulk and sub-standard flashing.

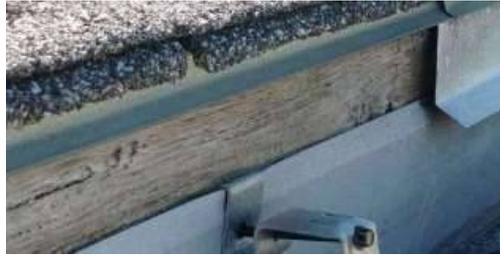
Photo 13-2 Missing drip edge flashing in fascia area

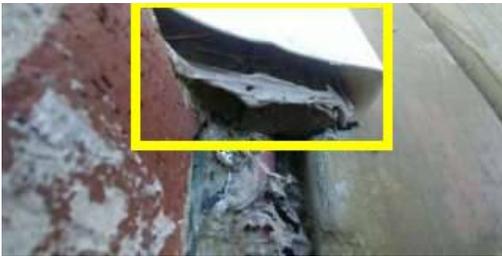
16) *Maintain* - Caulk was missing in some areas. For example, at siding-trim junctions. Recommend that a qualified person renew or install caulk as necessary. Where gaps are wider than 1/4 inch, an appropriate material other than caulk should be used. For more information, visit:

Photo 16-1 Missing caulk and sub-standard flashing.

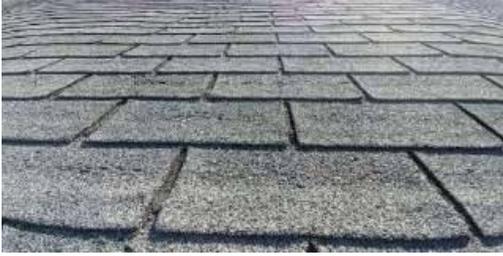
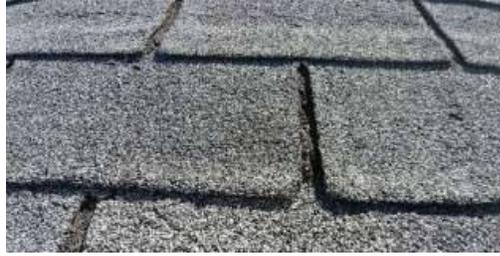
18) *Major Defect, Evaluate* - The roof surface appeared to be near the end of its service life and will likely need replacing in the near future even if repairs are made now. Recommend discussing replacement options with a qualified contractor, and budgeting for a replacement roof surface in the near future. The client may also wish to consider having a qualified contractor attempt to issue a "5 year roof certificate."

Photo 18-1 Deteriorated roofing shingles due to inadequate ridge and soffit ventilation

Photo 18-2 Deteriorated roofing shingles due to inadequate ridge and soffit ventilation

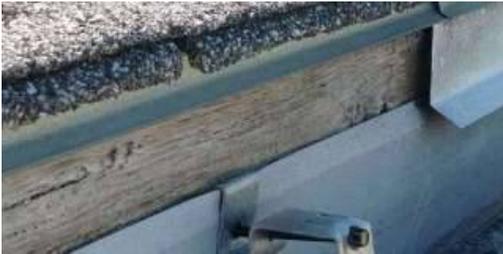
19) *Repair/Maintain* - One or more roof flashings were missing. Leaks can occur as a result. This is a conducive condition for wood-destroying organisms. Recommend that a qualified person repair as necessary.

Photo 19-1 Missing drip edge flashing in fascia area

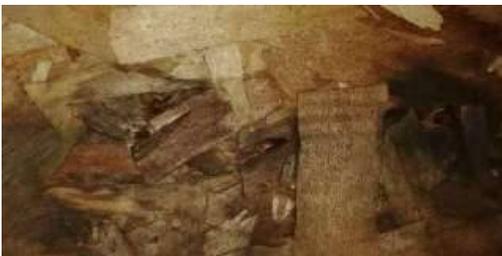
Photo 24-1

24) *Repair/Replace, Minor Defect, Evaluate* - Rusted roofing nails and somewhat deteriorated OSB roofing board was observed. This is an indication of moisture or water intrusion or condensation due to substandard ventilation or roof covering penetration. This condition is in need of further evaluation and correction. Adequate ridge, soffits(eaves baffles) ventilation also recommended by a qualified contractor.

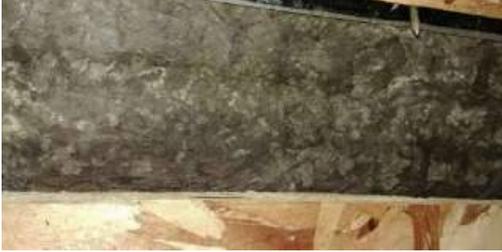
25) *Repair/Replace, Evaluate* - One or more sections of the roof structure appeared to have substandard

ventilation, vents were undersized. This can result in high attic and roof surface temperatures, reduce the life of the roof covering materials, and/or increase cooling costs. High levels of moisture are also likely to accumulate in the roof structure or attic, and can be a conducive condition for wood-destroying organisms. Standard building practices require one free square foot of ventilation for every 150 square feet of attic space, and that vents be evenly distributed between the lowest points of the roof structure and the highest points to promote air circulation. Often this means that both soffit vents and ridge or gable end vents are installed. Recommend that a qualified contractor evaluate and repair per standard building practices.

Photo 25-1 Inadequate ridge ventilation. Very minimal air gap was observed

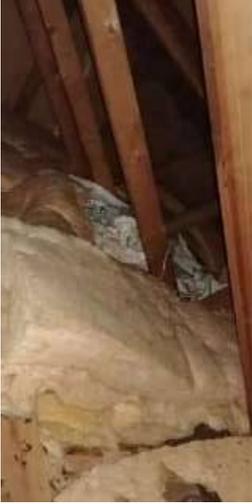
27) *Repair/Maintain* - The ceiling insulation in one or more areas of the attic was compacted or uneven. Heating and cooling costs may be higher due to reduced energy efficiency. Recommend that a qualified person repair, replace or install insulation as necessary and per standard building practices (typically R-49).

Photo
27-1 Indication of
various activities,
moved and/or
compressed
insulation, debris
and foreign
materials and
insufficient
insulation

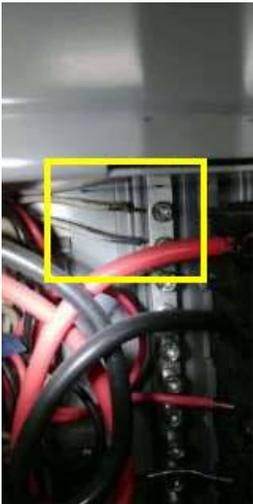
32) *Safety, Repair/Replace, Evaluate* - Charred wiring was observed. This is an indication of some problems. Recommend further evaluation by a qualified electrician.

Photo
32-1 charred
wiring.

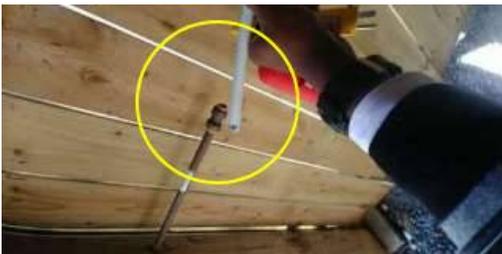
37) *Repair/Replace* - Damaged pipe to backyard hose bib was observed. This condition is in need of correction.

Photo 37-1 Damage plumbing pipe to backyard hose bib

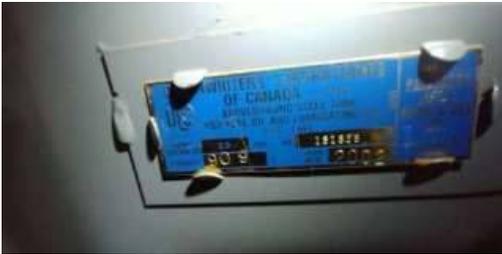
Photo 42-1

42) *Repair/Replace* - Oil tank was manufactured in 2002. Typical lifespan is 10 - 15 years. This oil tank is beyond end of life and needs replacement.

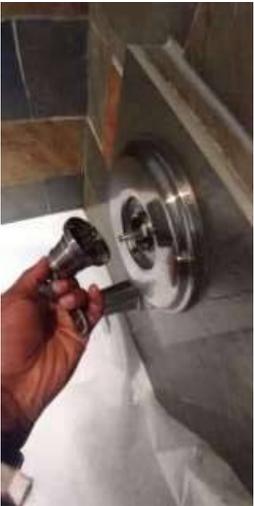
45) *Repair/Replace* - One or more bathtub faucet handles at location(s) #B were loose. Recommend that a qualified person repair or replace handles as necessary.

Photo
45-1 Disconnected
bathroom/ shower
handle

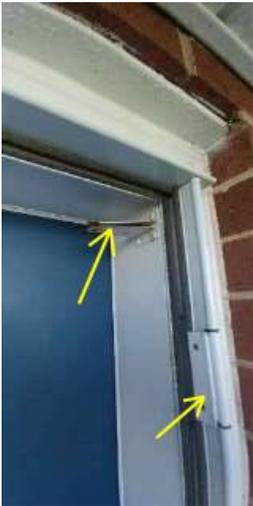
51) *Repair/Replace* - Storm doors in the back and front were missing or removed. Storm doors help protect exterior doors from weather elements and are recommended. Recommend installing storm doors where they were removed.

Photo
51-1 Evidence of
storm doors
previously installed
